Wall Stud Cutting and Notching

2019 California Building Code, Section 2308. (also see 2019 California Residential Code R602.6)

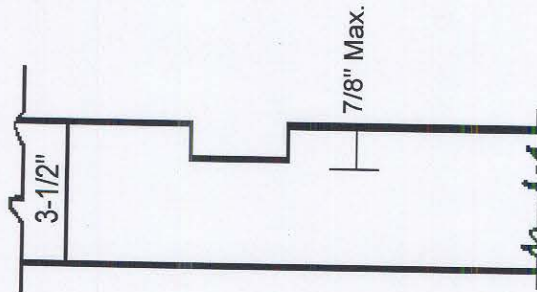
CUTTING & NOTCHING

25% allowed exterior & bearing walls

CBC 2308.5.9 Cutting and notching. In exterior walls and bearing partitions, any wood stud may be cut or notched to a depth not exceeding 25 percent of its width. Cutting or notching of studs to a depth not greater than 40 percent of the width of the stud is permitted in non-bearing partitions supporting no loads other than the weight of the partition.
